| <b>Project Name:</b><br>Gold King Mine | <b>Site Location:</b><br>Silverton, San Juan County, Colorado | <b>Project No.</b><br>0001/1408-01 |

## PHOTOGRAPH LOG

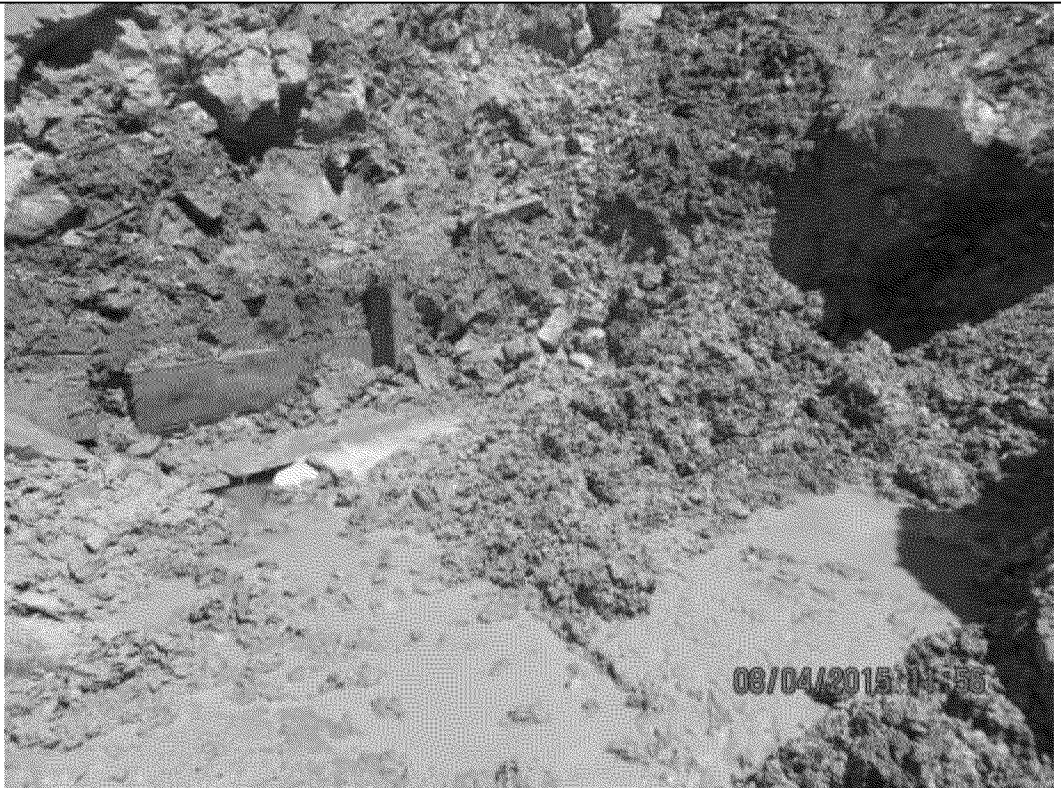
| <b>Photo No.</b><br><b>9</b> | <b>Date:</b><br>08/04/2015 | |

| <b>Description:</b><br>First signs of adit, support pillar with lagging. | | |

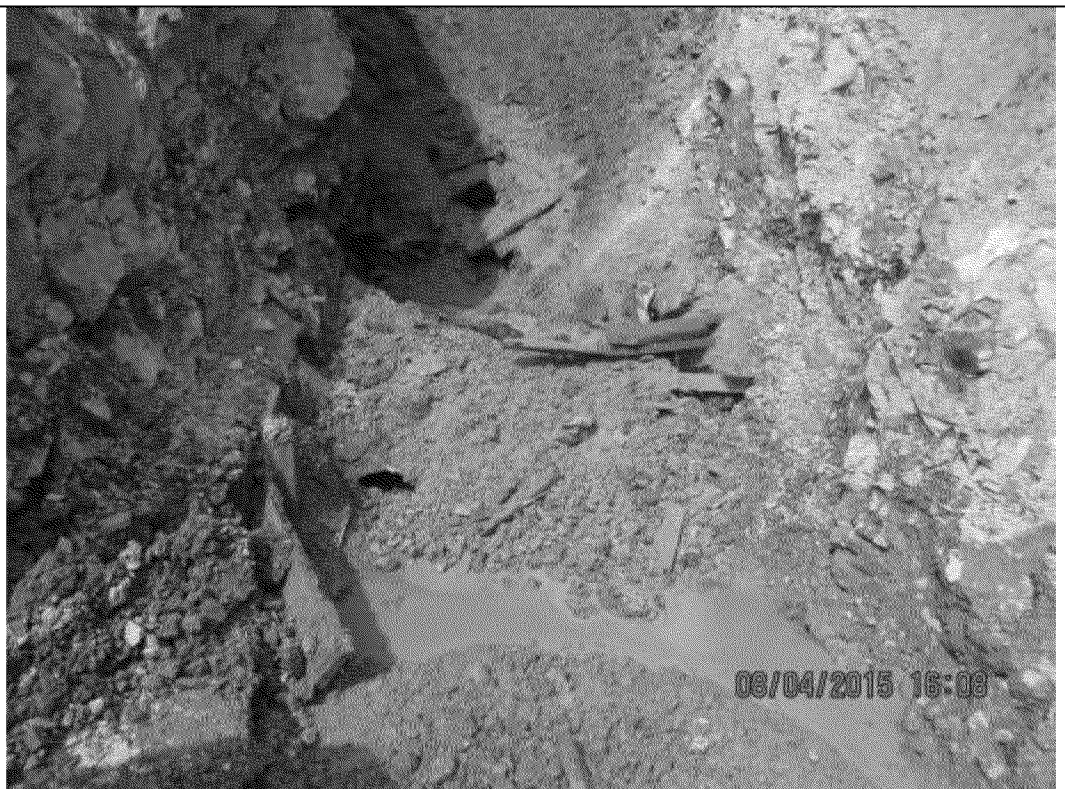
**Photo No.**  
**12**

Collapsed supports uncovered above anticipated adit, no sign of bedrock above the adit area.

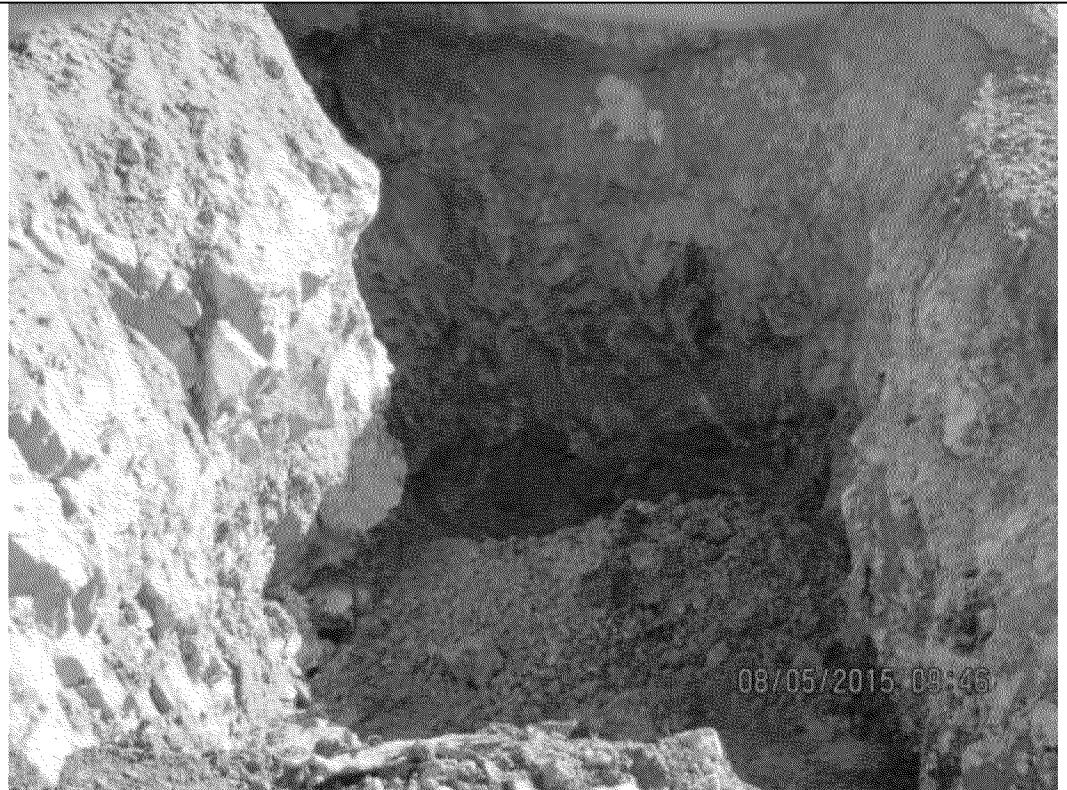
**Photo No.**  
**15**

Bedrock found above the anticipated adit.

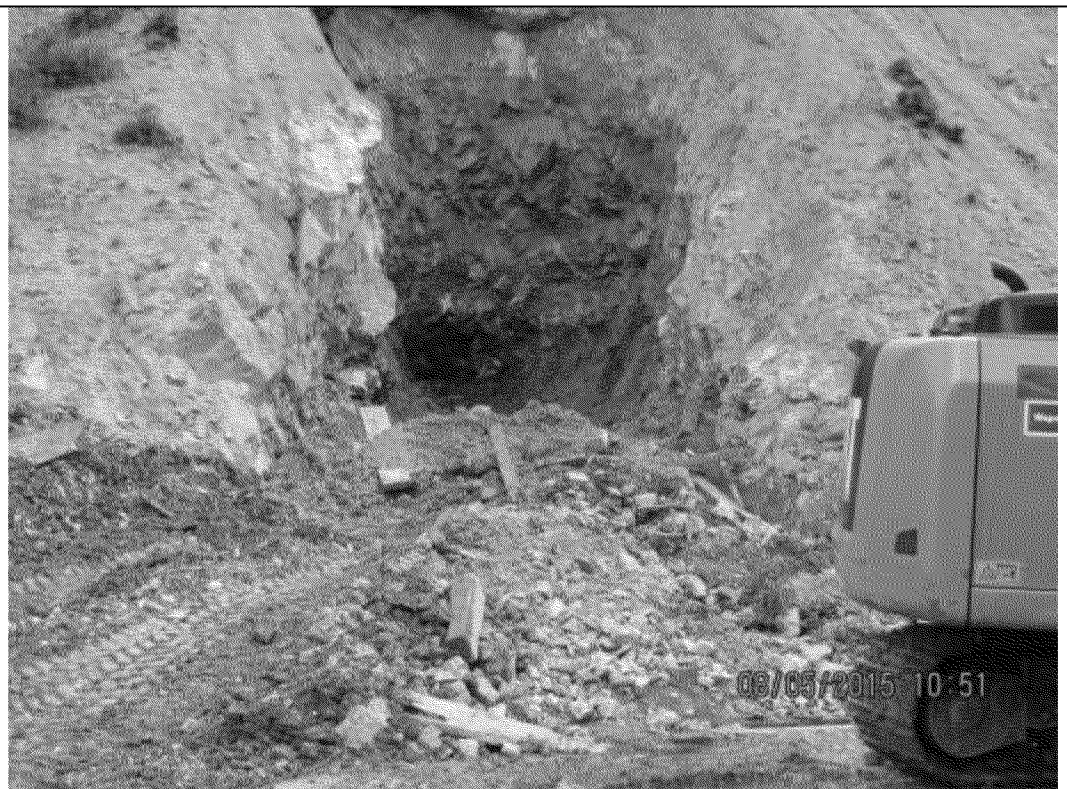
**Photo No.**  
**16**

Cleaning out excavated material, small leak.

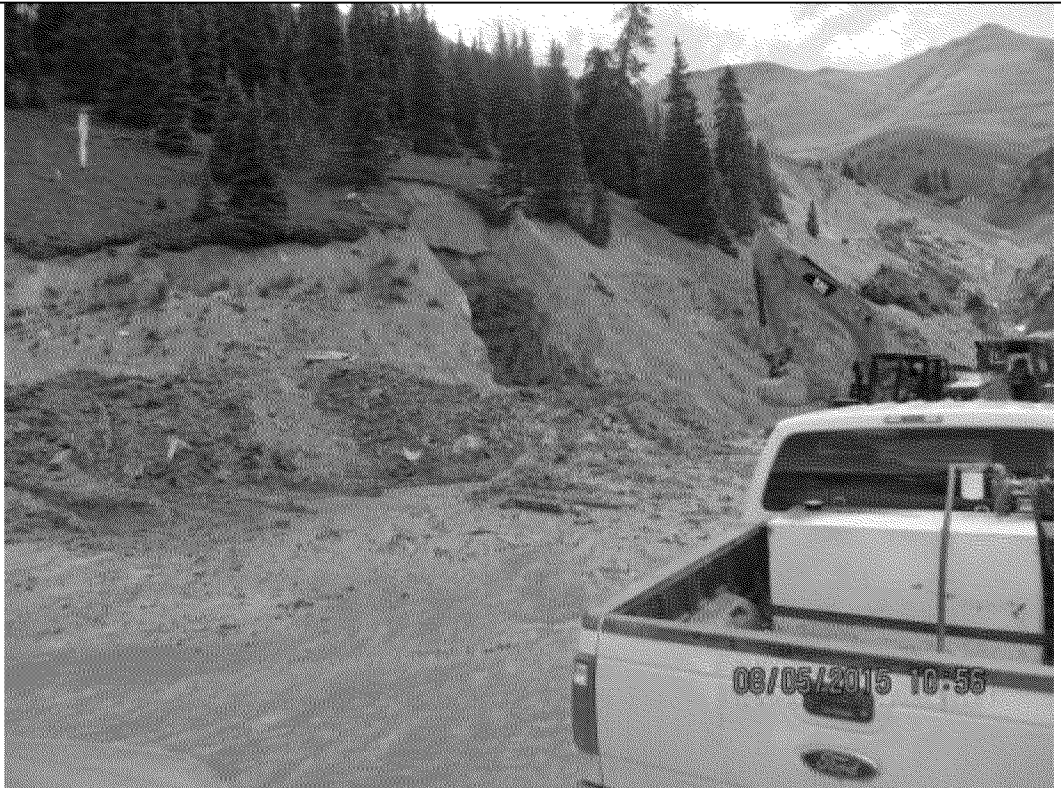
| <b>Photo No.</b><br><b>19</b> | <b>Date:</b><br>08/05/2015 | |

| <b>Description:</b><br><br>Adit flow increasing. | | |

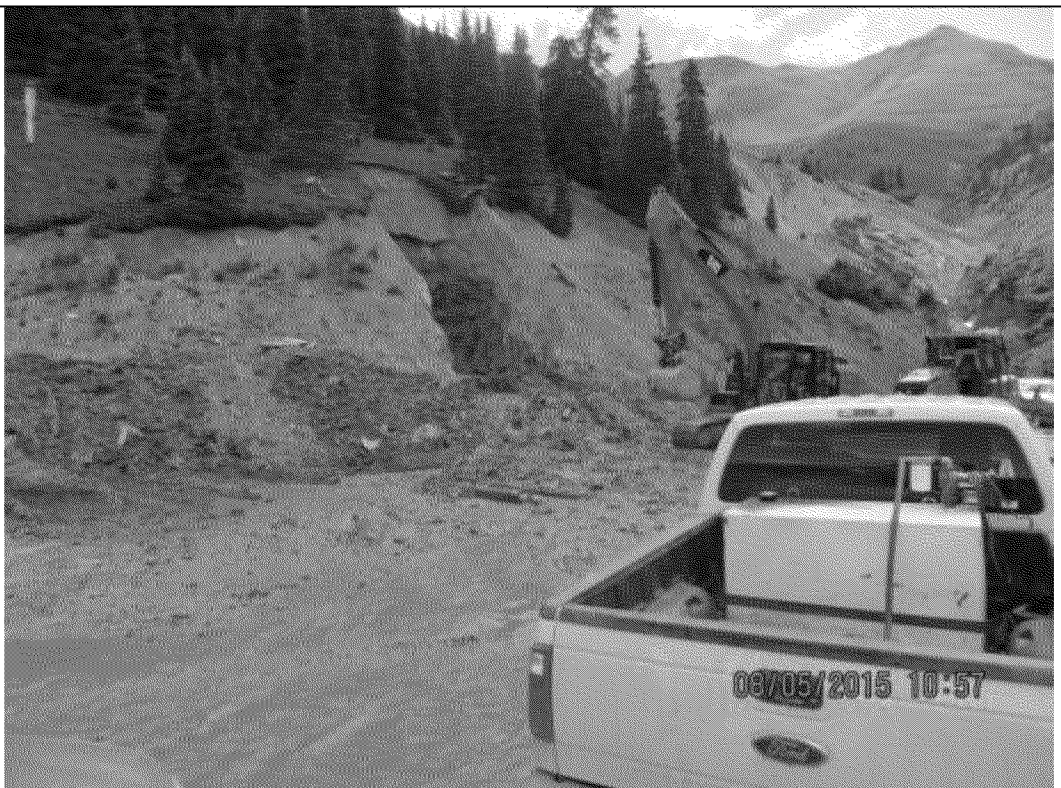
| <b>Photo No.</b><br><b>20</b> | <b>Date:</b><br>08/05/2015 | |

| <b>Description:</b><br><br>Water flooding out at increased rate. | | |

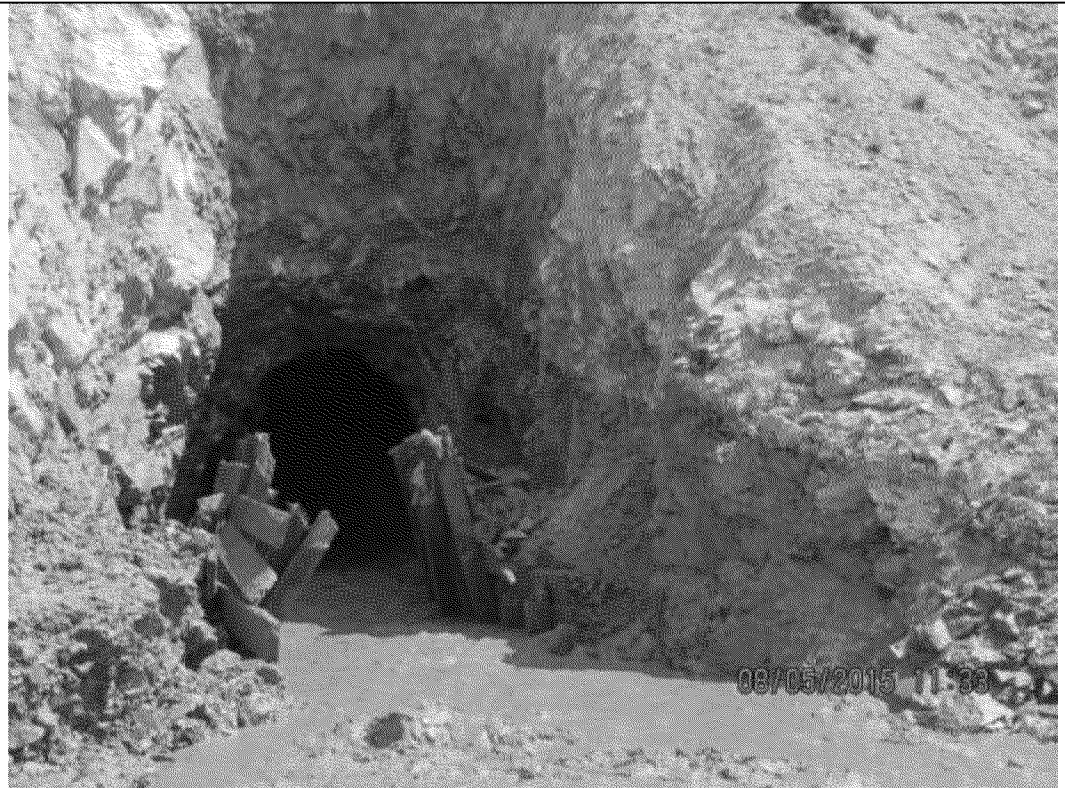
**Photo No.**  
**27**

Exposed adit, roughly 10 feet wide by 15 feet high.

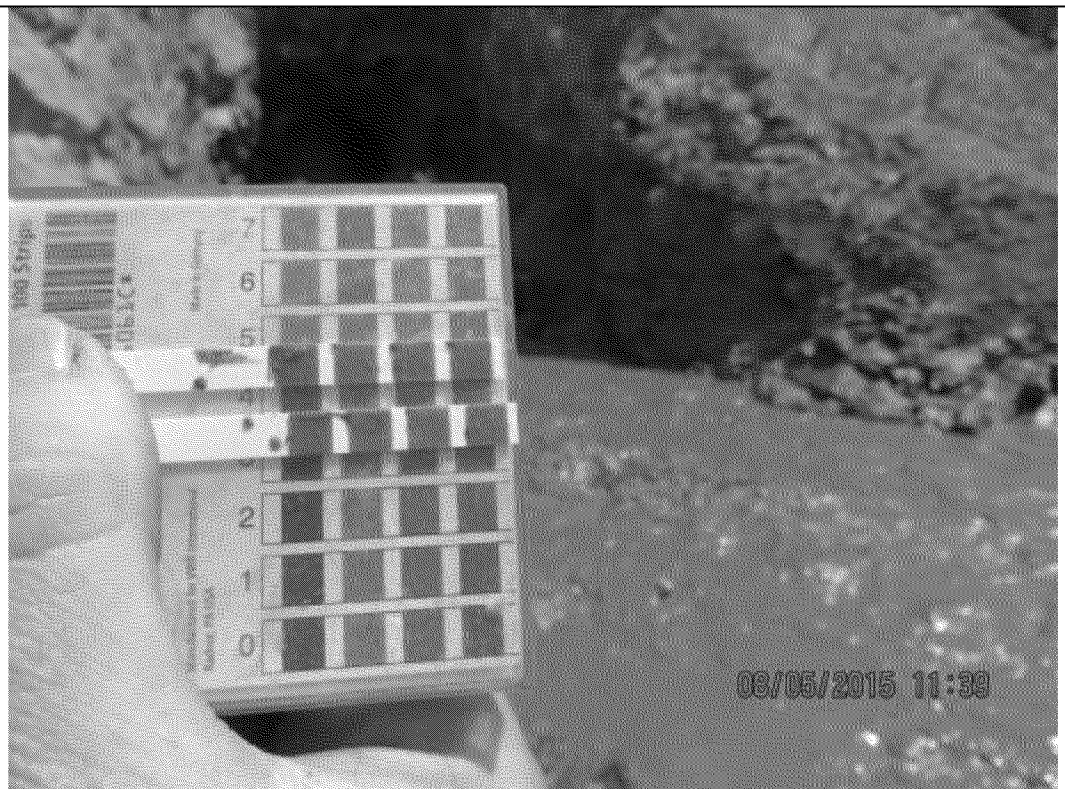
**Photo No.**  
**28**

pH of discharge water is approximately 4 to 4.5.

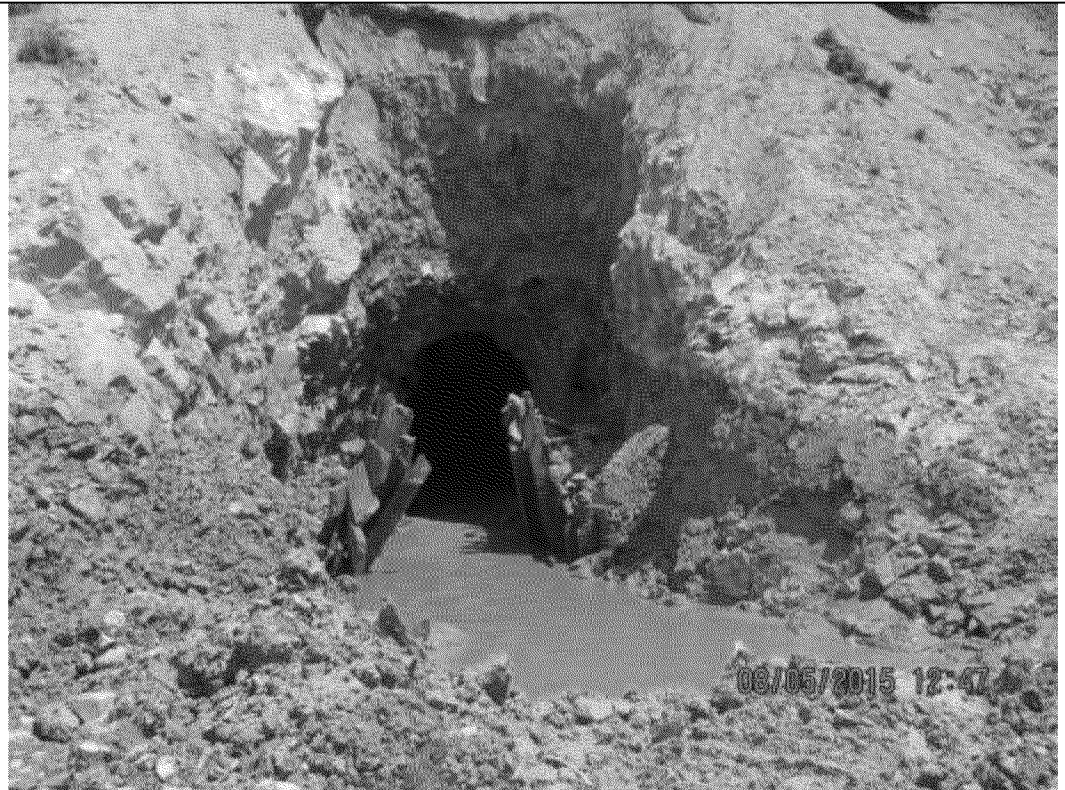
**Photo No.**  
**39**

No changes visible in adit structure or supports. Sloughing of materials inside the mine can be heard.

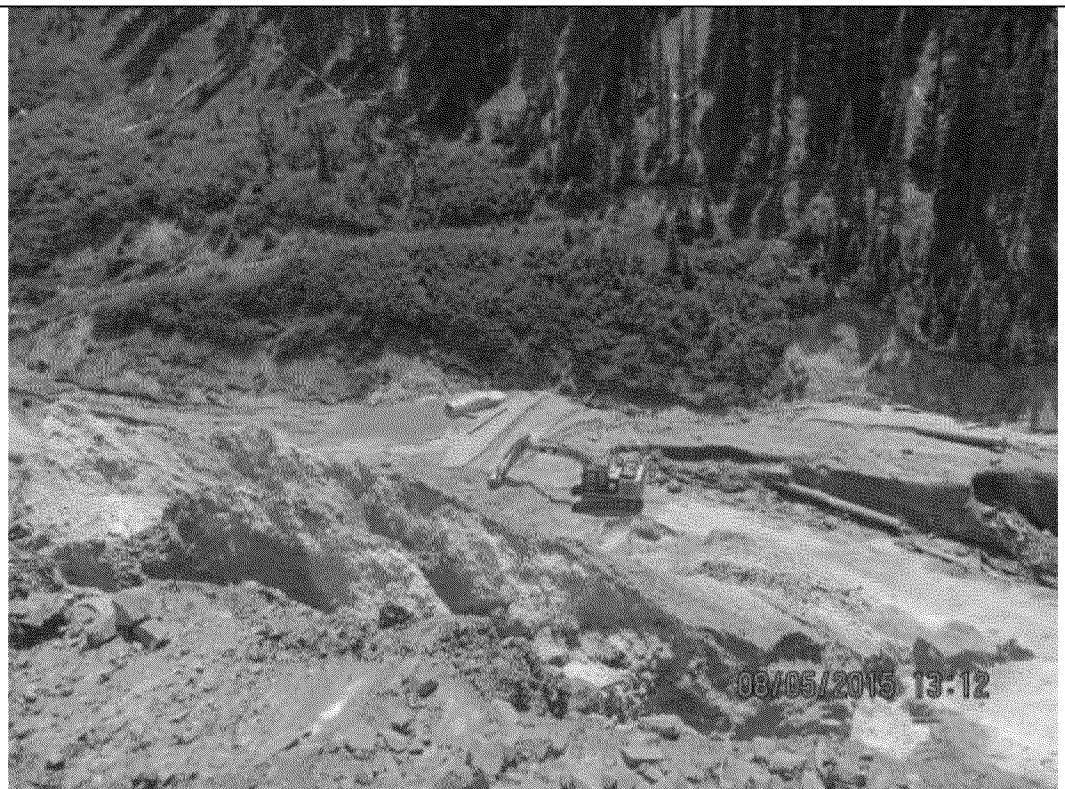
**Photo No.**  
**40**

Excavator progresses to washed out North Fork crossing.

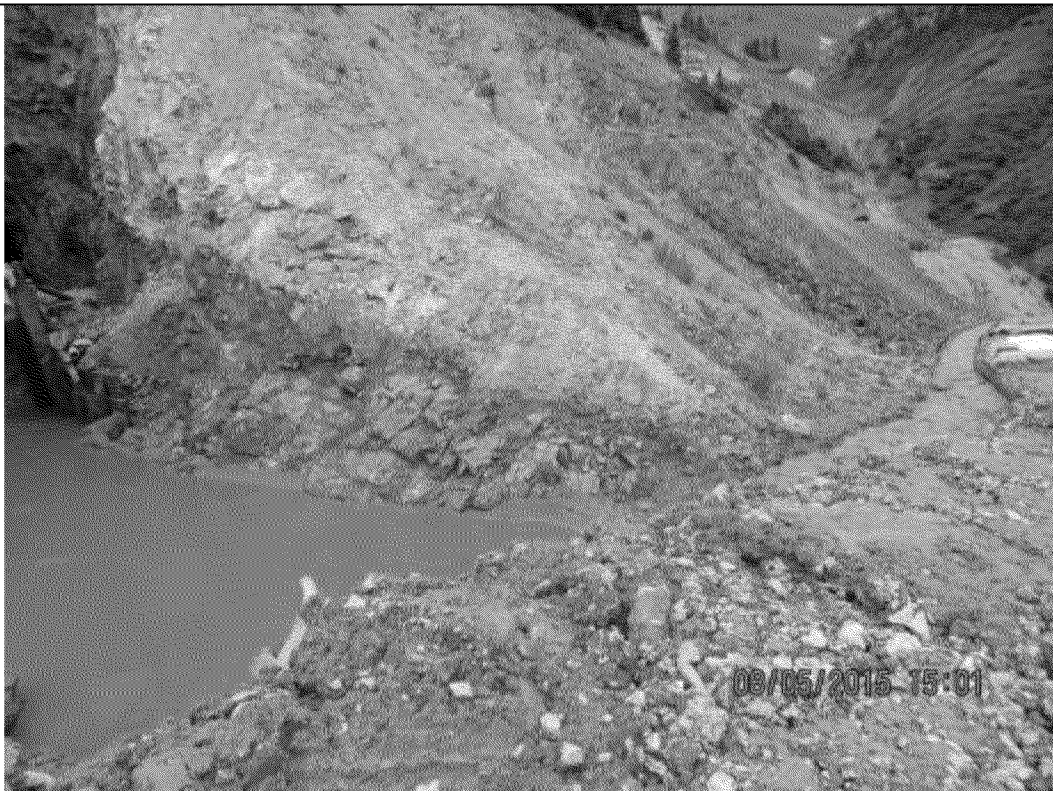
| <b>Photo No.</b><br><b>48</b> | <b>Date:</b><br>08/05/2015 | |

| <b>Description:</b><br>Flow path from adit, water flow appears to have stabilized around 1400. | | |

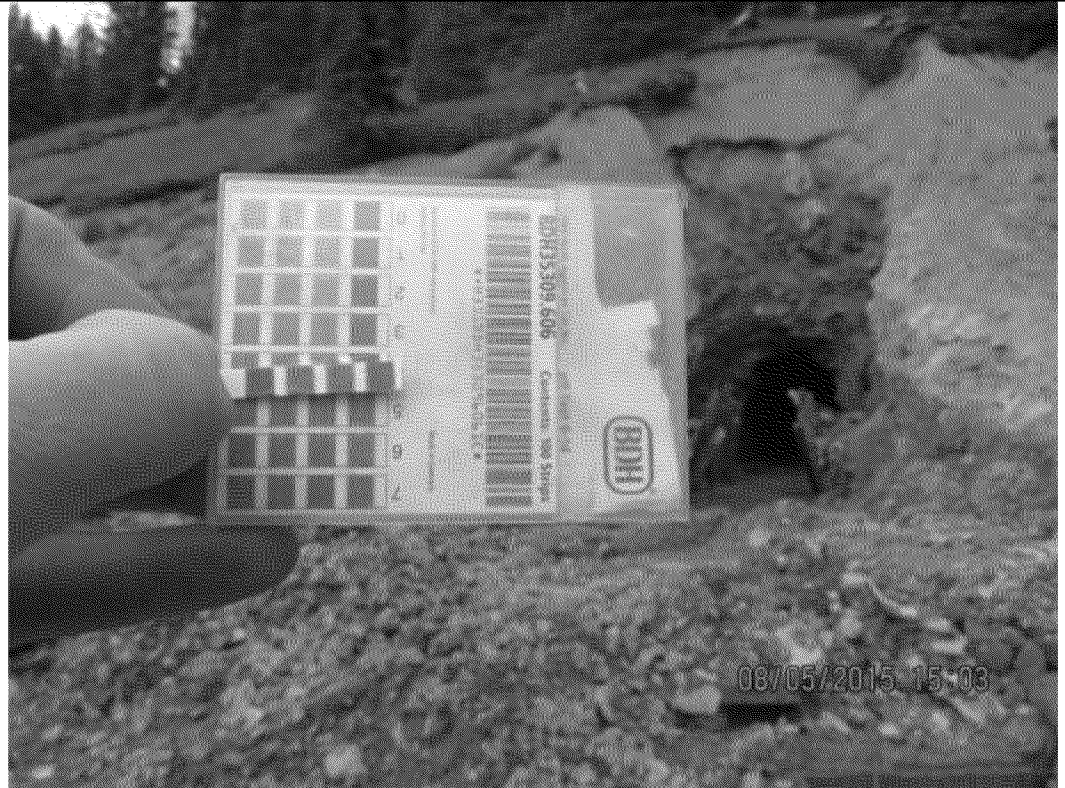
**Photo No.**  
**49**

pH measured at approximately 4.5.
